Manhole Inspection Summary

Manhole # S29M1_003MH

Insp Date: **2/26/08 10:18 AM**

Location Address: **Giles Rd.**

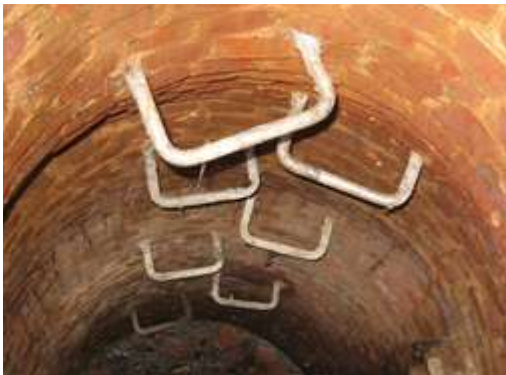
Steps

Count: **7** Missing: **0** ☐ Corroded

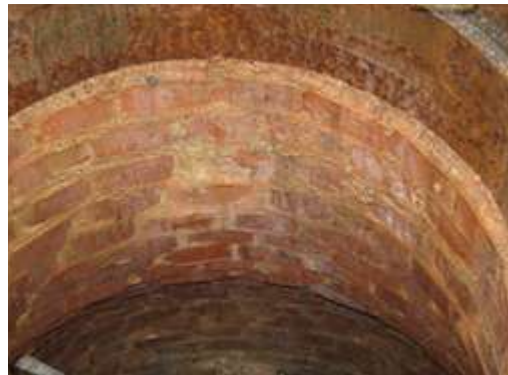
Defect 2

Offset: **0** (in.)

Frame offset

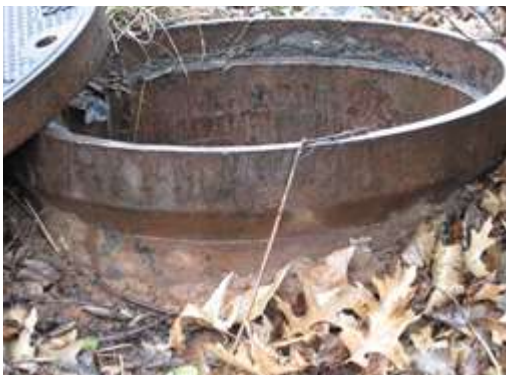
Defect 1

Diameter: **24** (in.) Length: (in.) Dist A/B Grade: **7** (in.)

Above grade

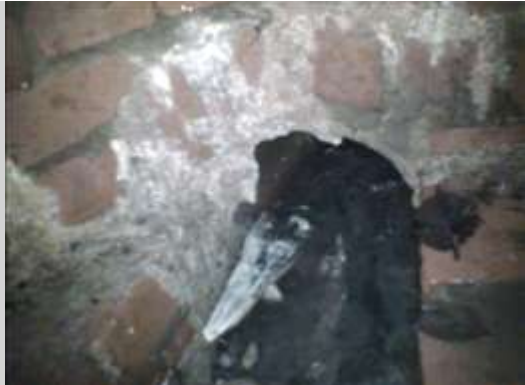
12 O'Clock Outflow

8 in. Circular Gravity Sewer
Pipe Out @ 12 O'Clock

Pipe Height: **8.4** (in.) Rod and Bar (Angled)
Pipe Material: **Unknown** ☐ Pipe Lined
Invert Depth: **12.21** (ft.) Flow Characteristics: **Fast**
Deposits: ☒ None ☐ Mud ☐ Sludge ☐ Debris ☐ Grease
Silt Depth: (in.) Deposits Extent:
Infiltration: **None** Pipe Seal Cond: **Sound**

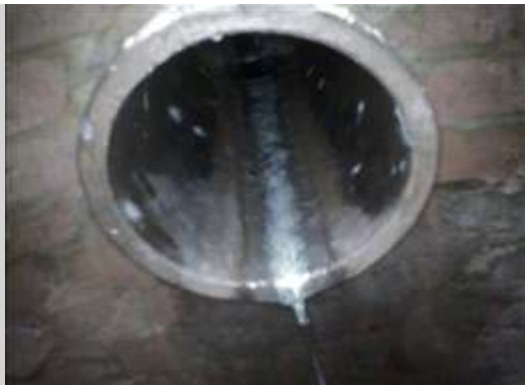
7 O'Clock Inflow

8 in. Circular Gravity Sewer
Pipe In @ 7 O'Clock

Pipe Height: **8.4** (in.) Rod and Bar (Angled)
Pipe Material: **DIP/CI** ☐ Pipe Lined
Invert Depth: **6.06** (ft.) Flow Characteristics: **Fast**
Deposits: ☒ None ☐ Mud ☐ Sludge ☐ Debris ☐ Grease
Silt Depth: (in.) Deposits Extent:
Infiltration: **None** Pipe Seal Cond: **Sound**

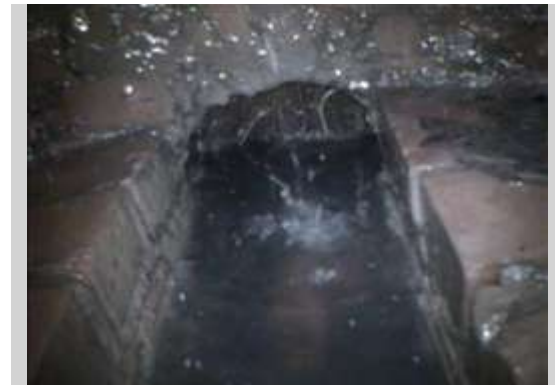
Drop In @ 7 O'Clock

Drop: **Outside** Rod and Bar
Angled: **Yes** Reading: **11.39** (ft.)
Inv Depth: **12.39** (ft.)
Drop Condition: **Open**
